Literature Review on Photoluminescent Material Used as a Safety Wayguidance System

IRC-RR-214

**Fire Research
Institute for Research in Construction
National Research Council**

RESEARCH REPORT #214

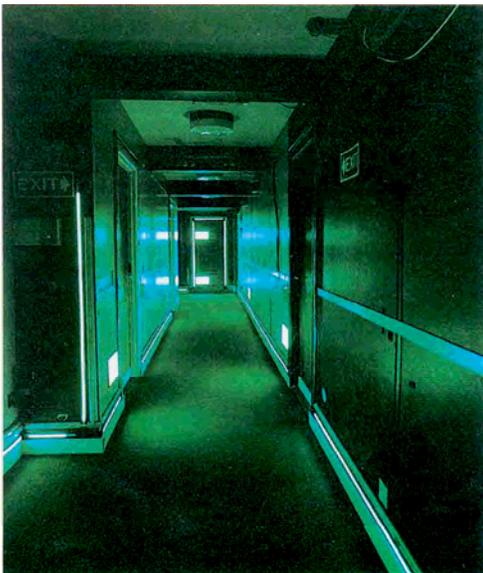
Figure 5: Electroluminescent system, BRE study [14]

BRE conducted another similar study in 1993 [13]. The study evaluated a new approach to emergency lighting based on providing wayfinding information with low level lighting (LLL) wayguidance systems, also referred to as LLL tracks. In addition to directional signage, exit signs, door markings, wall markings and other components that compose a safety wayguidance system, LLL provides information at floor proximity such as luminous lines outlining the lower edge of a corridor at the skirting board level. The impetus behind the development of such systems was the concern regarding evacuation in smoky conditions. LLL tracks are mainly used in building corridors, cinemas and aircrafts. The BRE study tested three systems: the first was a track of electro-luminescent lamps, the second was a track of miniature incandescent tungsten filament lamps (see Figures 5 and 6) and the third system was PLM marking. Conventional emergency lighting compliant with BS 5266 was also tested.

These systems were tested in a two-storey BRE test facility in which all windows were blackened out and external doors were light-tight. Within the building there was a simulated emergency escape route consisting of an L-shaped corridor on the ground floor leading to the 1st floor via a stairwell. The test route started on the ground floor, went through the L-shaped corridor, went up to the 1st floor via the stairwell and returned

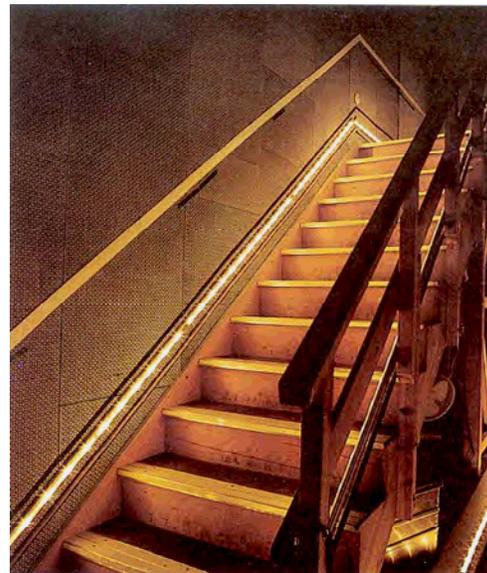
Figure 6: Incandescent system, BRE study [14]

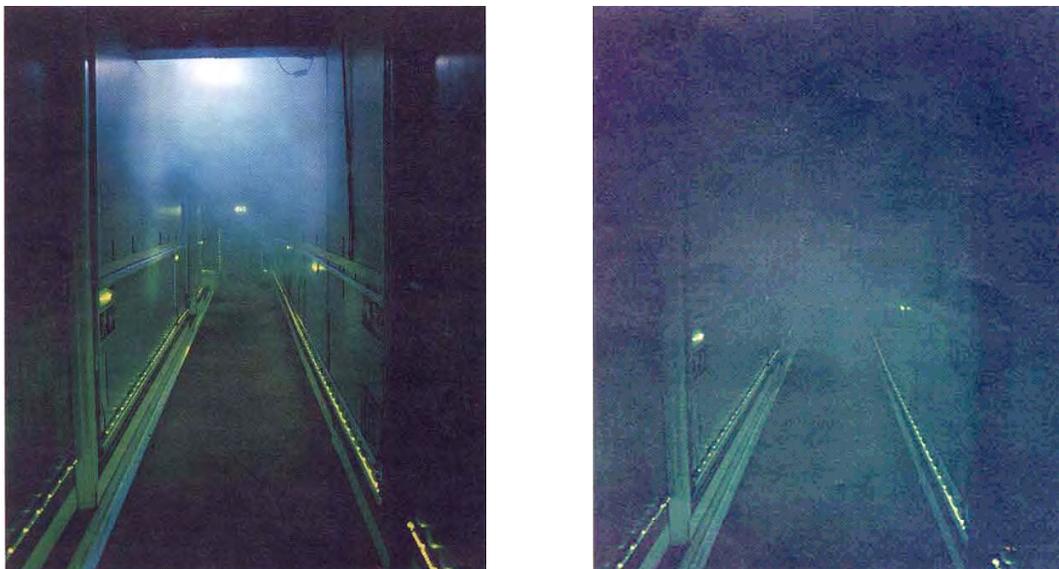
Figure 10: LED system progressively obscured by simulated smoke, BRE study [24]

- three different arrangements of light emitting diode (LED) LLL systems each consisting of an exit sign, doorframe and wall track, see Figure 10;
- one gaseous tritium light LLL system consisting of an exit sign, doorframe and wall track;
- one un-operated LED system consisting of an exit sign and directional signage reflecting emergency lighting.

It was also observed that point light sources such as the LED systems were more visible than planar light sources such as the photoluminescent and electroluminescent systems. Further, the presence of other lighting such as conventional emergency lighting reduced contrast by producing scatter, consequently making it harder to distinguish escape route elements. It was finally concluded that electrically powered wayguidance systems were more visible in smoke than conventional emergency lighting.
