Assessment of Photoluminescent Material During Office Occupant Evacuation

IRC-IR-774

Proulx, G.; Tiller, D.K.; Kyle, B.R.; Creak, J.

April 1999

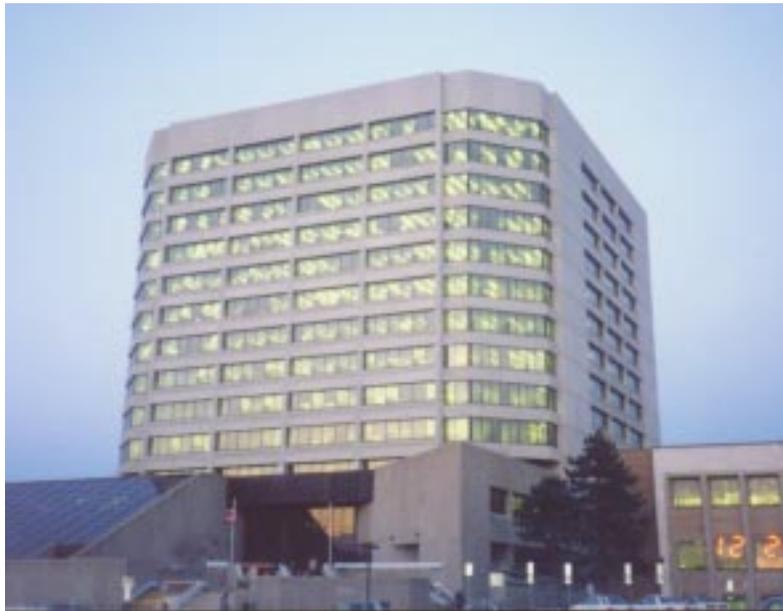
Figure1: The Jean Talon Building

The Jean Talon Building is a 13-story concrete structure built in 1979. The building, glazed on all sides, is almost square in shape, as presented in Figure 1. Each floor area of 3700 m² (approximately 65 m x 57 m) is an open plan concept divided into 4 quadrants, identified A, B, C and D. Work stations are divided with partition walls of 1.7 m in height. On the three floors studied (9, 10, 11), partition wall arrangements are similar. In the centre of the building is the core area, with elevators, washrooms, storage areas and a few enclosed meeting rooms. There is an average of 150 office workers on each floor doing research and clerical activities. The building has four identical windowless stairwells leading to the outside of the building. Figure 2 presents a typical floor plan of the Jean Talon building.

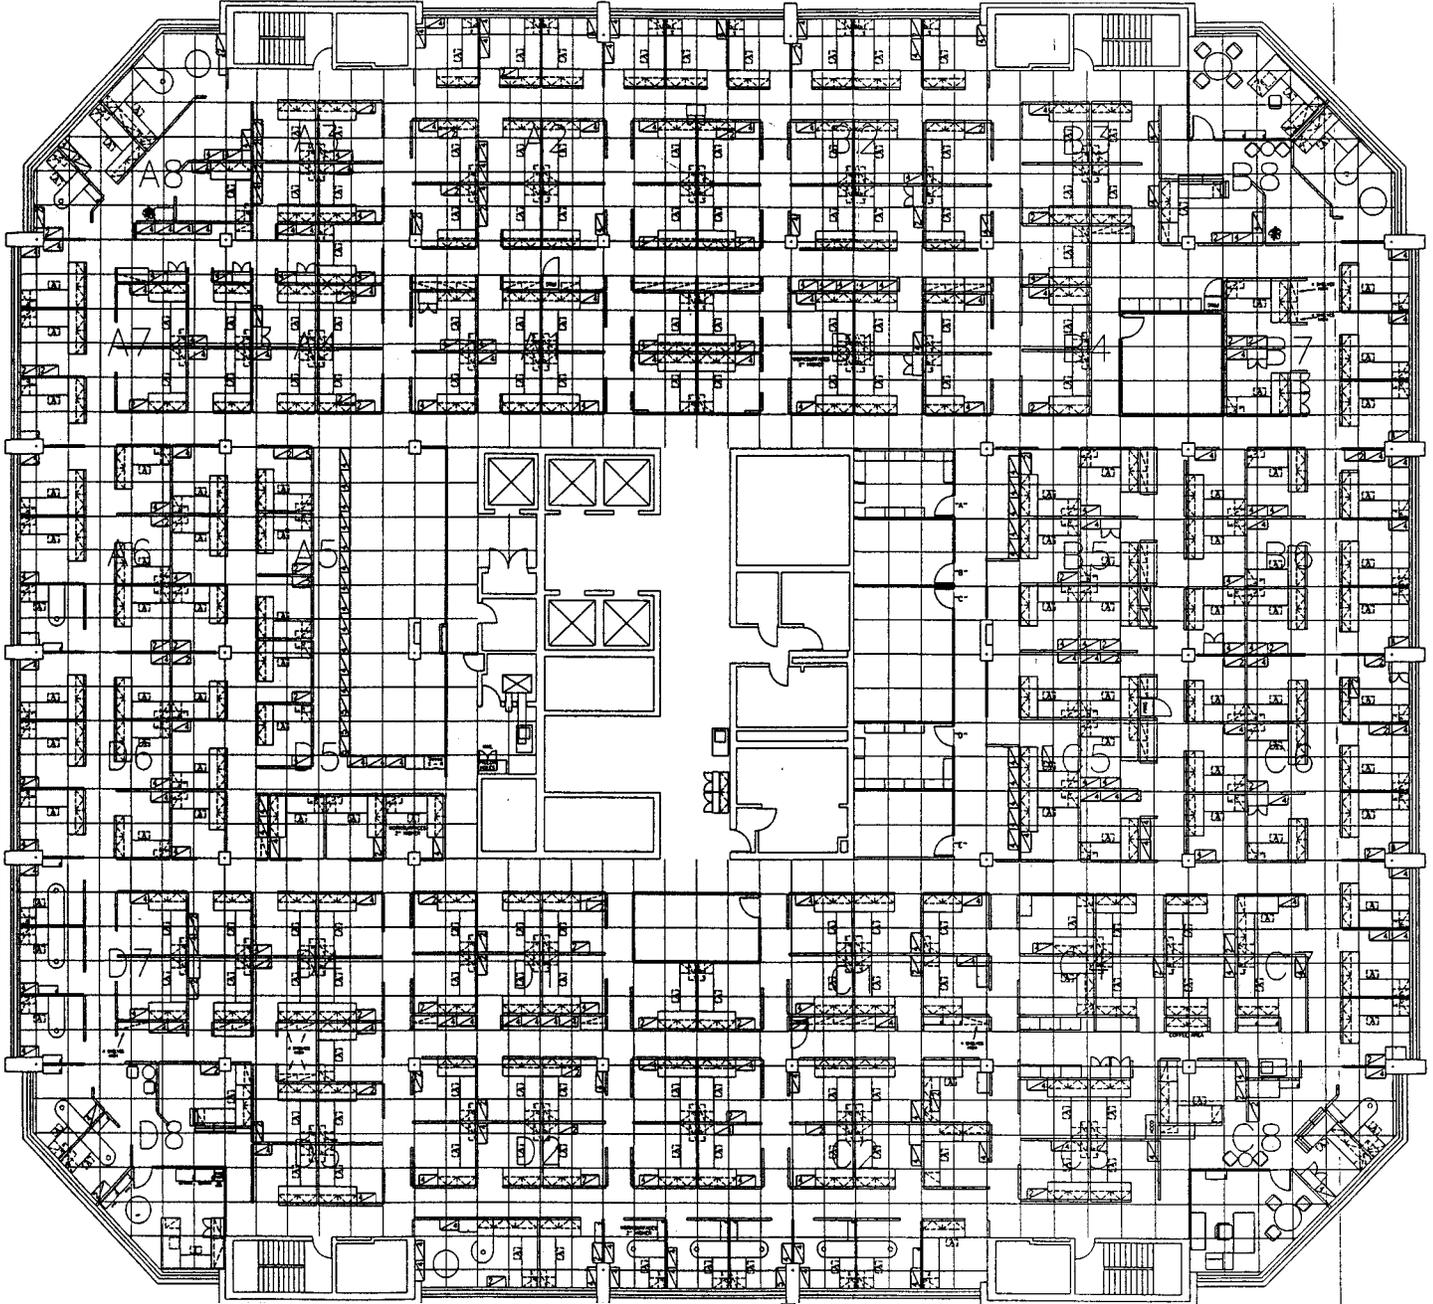
Stairwell A

Stairwell B

Stairwell D

Stairwell C

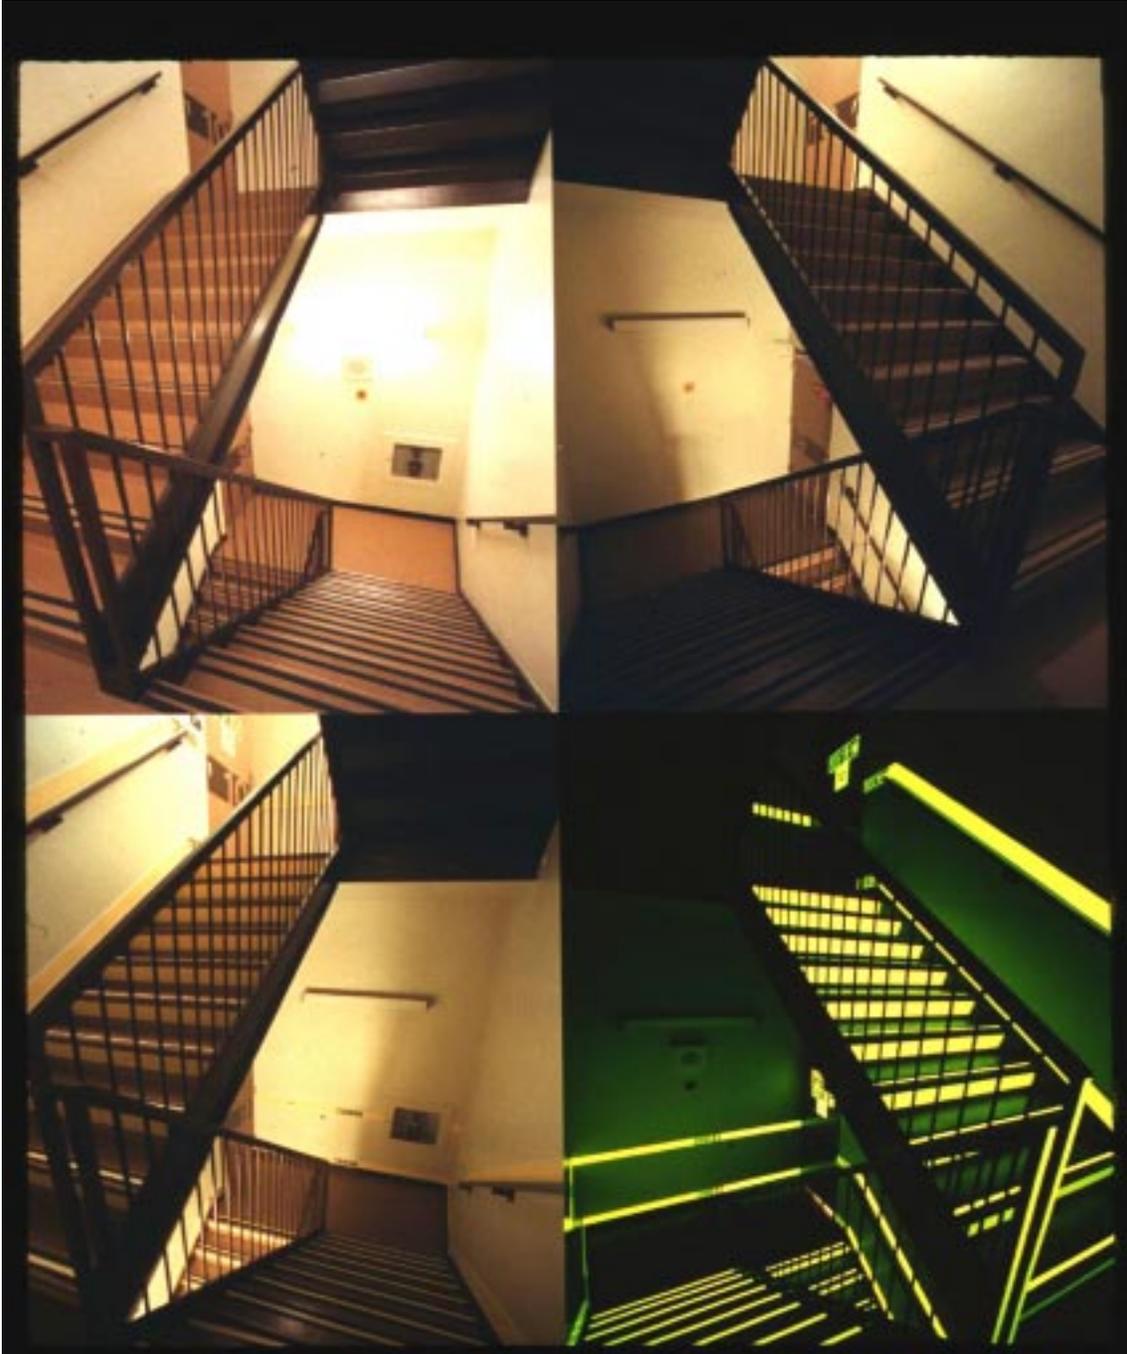
Figure 3: Pictures of the Four Stairwells

The picture on the upper left corner is Stairwell B with full lighting at an average of 245 lux. The picture on the upper right corner is Stairwell A with lighting reduced to 57 lux. The picture on the lower left corner is Stairwell D with PLM signs and a wayguidance system, and lighting reduced to 74 lux. The picture on the lower right corner is Stairwell C with PLM signs and a wayguidance system and no other lighting source provided.

The building's four identical stairwells presented different conditions, as shown in Table 2 and Figure 3. It is important to mention that, in this building, the stairwell emergency lighting is the full lighting with double-tube luminaires on every floor and mid-landing which provides a very well-lit stairwell of an average lighting of 245 lux. For this study, the lighting conditions in three of the stairwells were modified. Lighting in Stairwells A and D was modified to obtain a reduced output maintained above the COSH [19] requirements of an average of 10 lux and not less than 3.3 lux. To obtain this reduced output, 2 out of 3 double-tube luminaires were switched off in Stairwells A and D. With this design, Stairwell A had an average lighting of 57 lux and Stairwell D had an average lighting, slightly higher, of 74 lux. Stairwell D also had PLM signs and a wayguidance system installed. A few minutes before the evacuation, all lights were switched off in Stairwell C which had PLM signs and wayguidance system. Finally, Stairwell B received no treatment; it acted as the control stairwell.

Two of the four stairwells were equipped with PLM from the top floor of the building down to the bottom. The installation of the material was according to the PSPA Standard 002 Part 1 1997 [21], and safety signs according to BS 5499 Part 1 1990. As shown in Figure 3, the stairwell was equipped with two continuous wayguidance lines of 10 cm in width. One line was at the skirting board and the other 1 m from the floor. Directional signs were enclosed within these continuous lines. A 2 cm strip of PLM was fixed on the tread of each step and a 10 cm piece was positioned on the riser of each step. A sign identifying the floor number was installed on each door as well as a sign identifying the "Transfer Floors" on Floors 4, 9 and 13. Directional signs were positioned on each door and at mid-landing at 1.7 m from the floor. In accordance with Canadian practice, signs were positioned at the top of each exit door, identifying them as final exit. The material and installation costs for the stairwells were estimated at \$2500/floor.

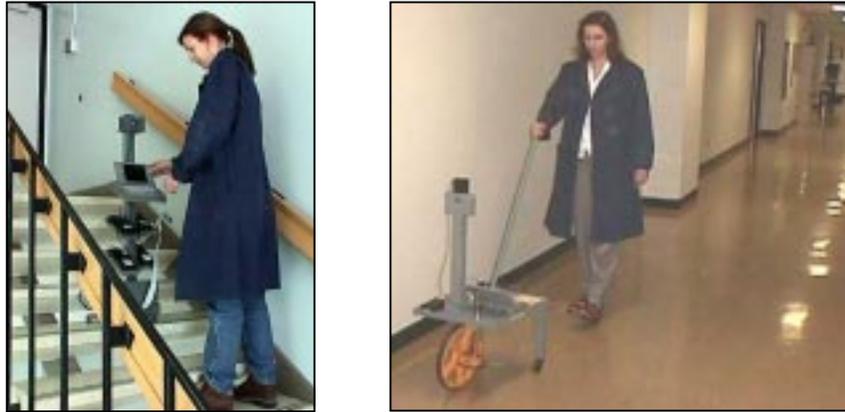
Figure 4: Data Acquisition in Stairwells

The picture on the left shows the configuration used in the stairwells (the stairwell depicted was not one measured in this study). The illuminance meters are mounted on a pillar such that the plane of the detectors is 1 m above the stair tread. The operator manually directs the software and data acquisition hardware mounted on the laptop computer to poll the illuminance meter, and store the measured values on the computer hard disk. Once the polling operation has been completed, the operator moves the apparatus to the next measurement location, and repeats the operation. The picture on the right shows the configuration used to collect measurements on the floors. The operator pushes the device along the centreline of the measurement path. As the calibrated wheel (circumference 1 m) turns, the data acquisition system is directed to poll the illuminance meters and store the resulting value in the computer once every 25 cm of travel.

Light levels were measured on the building floors and in the stairwells 1 m above floor level using recently calibrated Minolta T-1M illuminance meters. The meters were connected to an automated data acquisition system presented in Figure 4, which polled the meters and stored the resulting readings on a computer hard disk.

On Floors 9, 10 and 11, the operator pushed the measuring system along the centreline of the measurement path using a specially designed cart, presented in Figure 4. The operator walked the automated data acquisition system down the centreline of every path available to the occupants of these floors, following COSH recommendations (6.10.1.B) [19]. In accordance with IESNA [27] recommendations, measurements on the building floors were collected at night (IESNA, 1993, p. 60). Summary statistics describing illuminance measurements are presented in Table 4 and Figures 5 and 6.
